Manhole Inspection Summary

Manhole # S29I__049MH

Insp Date: **9/4/08 12:39 PM**

Location Address: **828 W.Lombard St.**

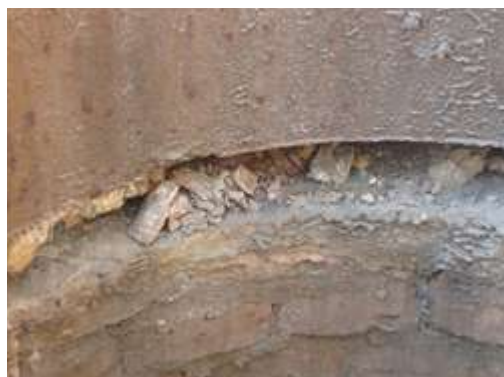
Defect 1

Condition: ☐ Sound ☐ Cracked ☐ Root Intrusion ☒ **Loose Brick** ☐ Deteriorated

Infiltration: ☐ None ☐ Joint ☐ Cracks ☒ **Mortar** ☐ Roots ☐ Wall

missing brick and mortar at chimney with infiltration

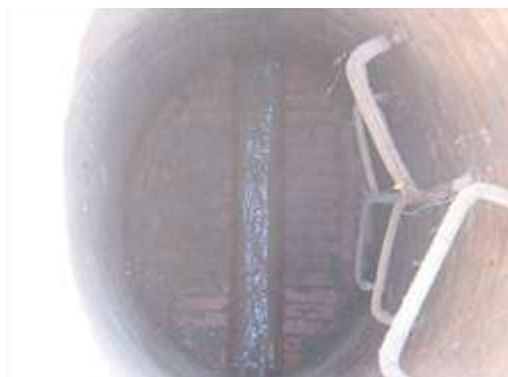
Defect

Steps Count: **6** Missing: **0** ☒ **Corroded**

corroded steps

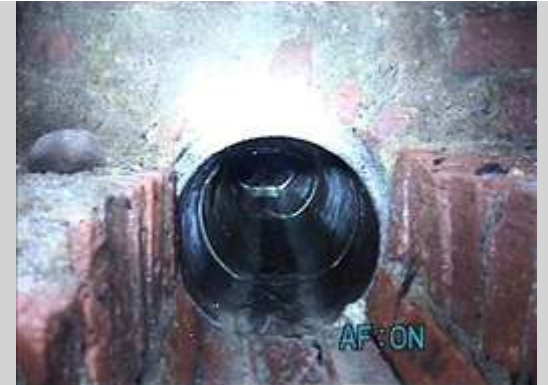
12 O'Clock Outflow

Pipe Height: **8.4** (in.) Rod and Bar (Angled)
Pipe Material: **Clay** ☐ Pipe Lined
Invert Depth: **9.90** (ft.) Flow Characteristics: **None**
Deposits: ☒ None ☐ Mud ☐ Sludge ☐ Debris ☐ Grease
Silt Depth: **0** (in.) Deposits Extent:
Infiltration: **None** Pipe Seal Cond: **Sound**

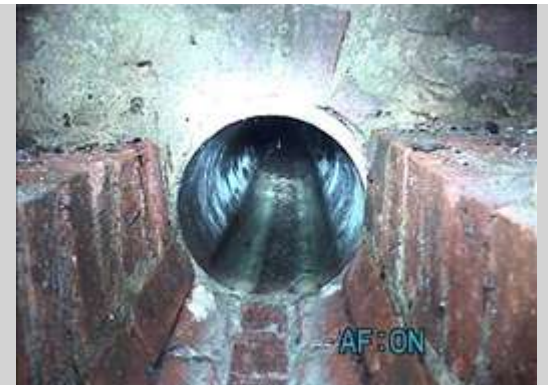
6 O'Clock Inflow

Pipe Height: **8.4** (in.) Rod and Bar (Angled)
Pipe Material: **Clay** ☐ Pipe Lined
Invert Depth: **9.87** (ft.) Flow Characteristics: **None**
Deposits: ☒ None ☐ Mud ☐ Sludge ☐ Debris ☐ Grease
Silt Depth: **0** (in.) Deposits Extent:
Infiltration: **None** Pipe Seal Cond: **Sound**
